## TRADITIONAL EXTERNAL TIMBER CLADDING IN MEDITERRANEAN CLIMATES.

**ABSTRACT:** The study analyzes the traditional external timber cladding in the Mediterranean climate, in order to better break down their behavior through time of some of them.

An analysis of timber cladding used outdoors is made, considering 3 case studies of houses (from year 1900 onwards, as traditional architecture) taking into account the way this coating has responded and developed as time has passed; and performing typologies of wood cladding in Mediterranean climates.

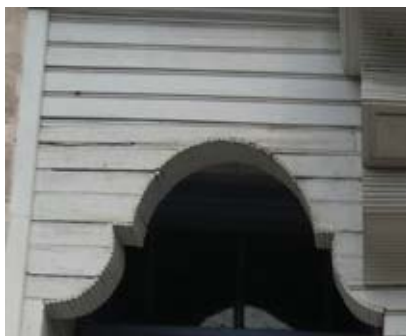
**Shrinkage of wood:** Timber movements in the north and south facades according to the continent (northern in South America and South in Europe), where it presents more damage from moisture and movement of wood due to greater presence of moisture and the rainfall that comes directly. This climate is characterized by very distinct seasons, being these facades (north and south respectively) the ones that suffer most in summer (high temperatures and high relative humidity) and winter (low temperature, rainfall and the presence of high relative humidity). It shows the damage of the joints of the boards, decay and openings (cracks) in these areas and the openings of windows and doors. It is also important to note that depending on the size of these wooden slats they will move, crack or change according to the way they were designed. In Cases A and C we have the same dimension of the slats (3" x 1"), which helps their dimensional changes not to be as important as opposed to the slats of the case B (5" x 1") that if we movements which have occurred in the sheathing and also by their morphology is easier for the wood to split. Cutting wood in tangential section lamas helps to control the dimensional changes.

Fig. 10 Case B, where the higher number of deformations is presented.

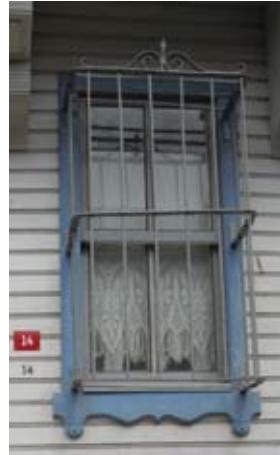
**Finishing Behavior:** Due to problems in maintaining the facades, great deterioration is shown especially in cases B and C. Since the finish has cracked and allowing to see the bare wood in many parts of the facade, due to the

fact that the wood was not treated, this house has deteriorated even faster. This is mainly seen in the frames of doors and windows in both cases.

Fig. 11 Case B Fails in the finishing of the window, cracking.

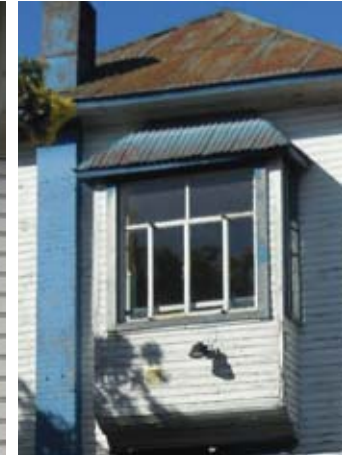
Fig. 12 Case C Fails in the finishing of the window, cracking.

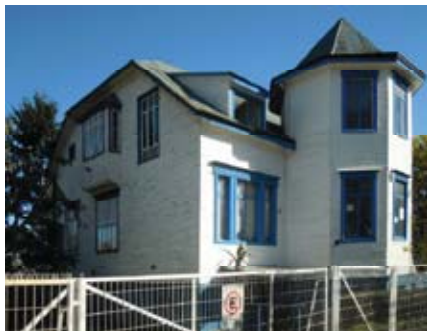
**Volumetry of the facade:** It is an important part in the composition of the facades, but when the house presents more outgoing volumes as in the cases B and C (most impaired), a greater number of meeting points is generated, accumulating moisture in the meeting places, especially in the facades, being the effects worse because of the rain and the sun in different seasons, as well as the presence of shadow which makes it degrade more easily as fungi agents appear deteriorating wood faster, especially when the house is not well maintained. As seen in the picture of case C which is the most affected one.

Fig. 16 Northern facade in case C, Temuco, Chile.

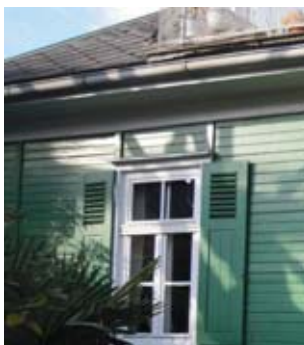
Fig. 17 Case A, collapse of the wooden slats on the window.

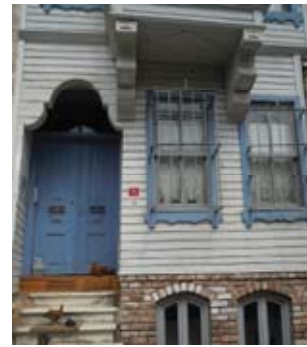
Fig. 18 Case B, sinking of the wooden slats on the access door and window scaling.
